Environmental Considerations Report

Pioneer Homes – East Lake 44 Keystone Road Project

February 13, 2018

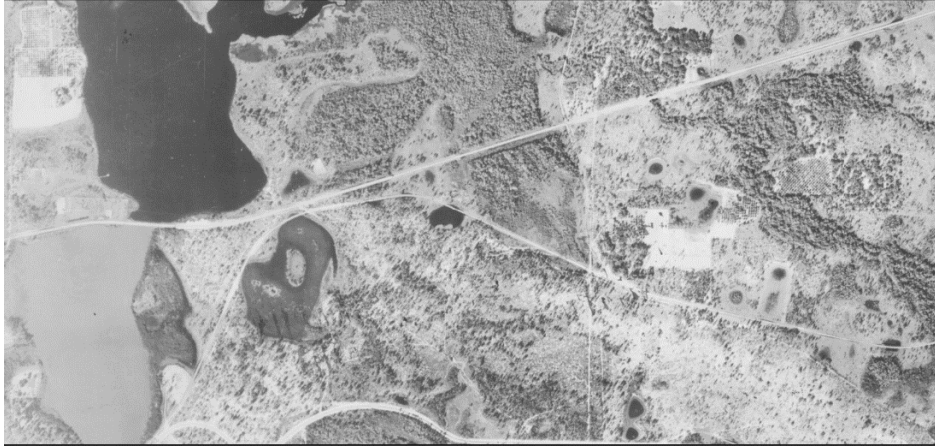
Figure 1.0 – 1941 Historical Aerial

This moderate quality freshwater marsh community is located in the northwestern portion of the Project site and is clearly shown as a depressional lake in the 1941 aerial (please reference **Figure 1.0 – 1941 Historical Aerial**). Even as early as 1941, the Project site, and specifically the freshwater marsh, were impacted, being severed by the construction of an unpaved roadway.
